## Roofing No. 3017

**Subject:** Comparing Polyiso and Molded Polystyrene from the past to today.

**Date:** August 2016 (Revised January 2019)

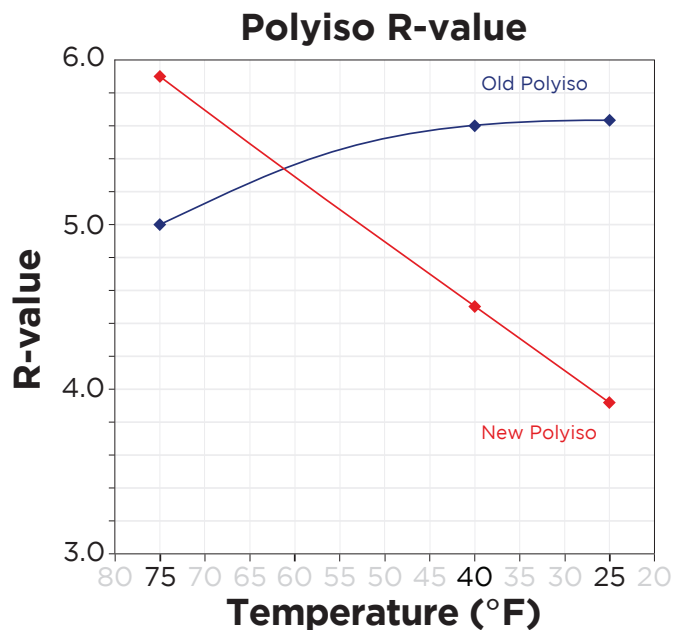
A plot of the R-value for the 17 year old polyiso and new polyiso demonstrates the dramatic change in polyiso insulation in recent years. “New” polyiso loses significant R-value at cold temperatures.

It is clear that the 17 year old polyiso R-value of R-5.0 at 75°F is well below the published R-value for polyiso of R-5.6. This is not surprising since polyiso insulation loses blowing agents and R-value with age. At colder temperatures, the R-value of the polyiso improved slightly.

It is clear that the R-value of “new” polyiso of 5.8 at 75°F meets the the published R-value for polyiso of R-5.6. This is not surprising since the polyiso insulation is new and has not yet lost its blowing agents and R-value which will occur with age. At colder temperatures, the R-value of the polyiso decreased dramatically. This loss of R-value for polyiso is a known phenomenon and has been documented extensively<sup>1,2</sup>.

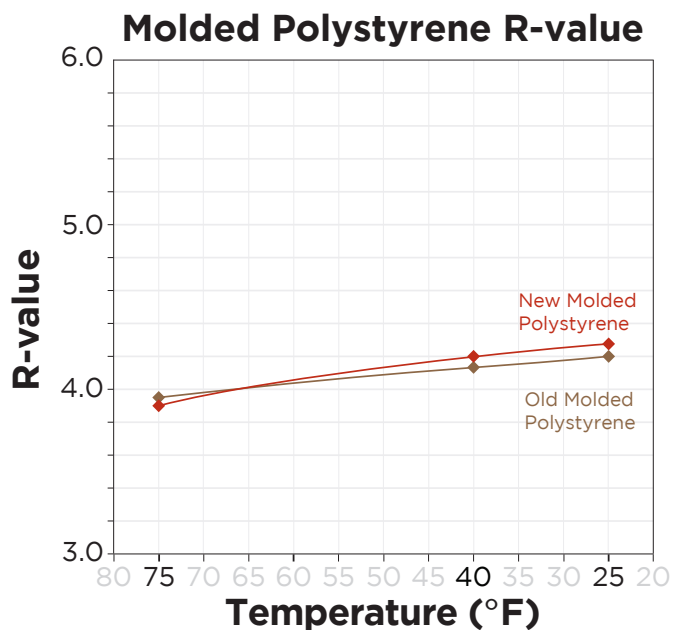
In comparison, the R-value for 17 year old molded polystyrene and new molded polystyrene are similar. This demonstrates that molded polystyrene can be trusted to have stable R-value performance.

The R-value for the 17 year old molded polystyrene at 75°F meets the published R-value of 3.8 for a Type VIII molded polystyrene product. This is not surprising since the R-value of molded polystyrene does not change with time. At colder temperatures, the R-value of the molded polystyrene increased.

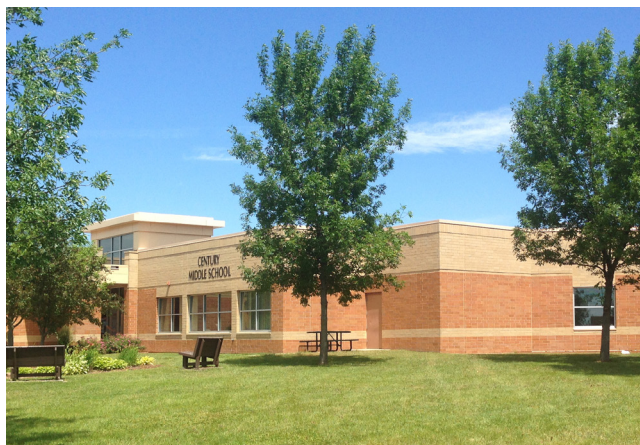
Figure 1. 17 year old Minnesota school

A school building located in Minnesota was undergoing a roofing system replacement in 2016 and it provided a perfect opportunity to evaluate the performance of the existing roof insulations. The school was originally built in 1999 and consisted of a combination of polyiso and molded polystyrene roof insulation. Samples of both products were removed from the roof and evaluated for R-value at various temperatures (See figures on page 3).

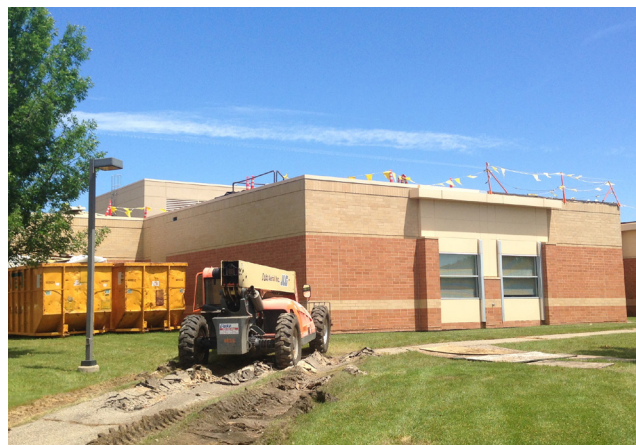
Figure 2. Roof replacement in progress

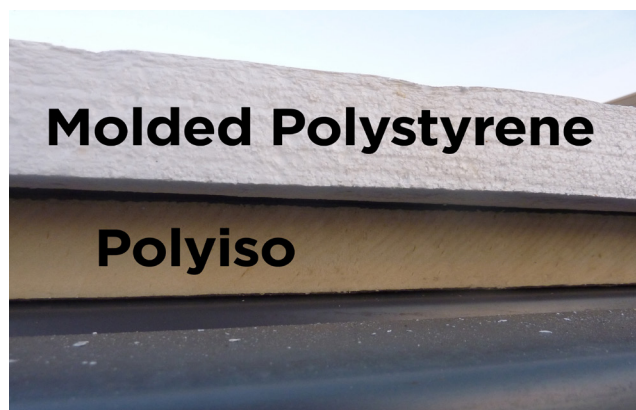
Figure 4. Existing roof components

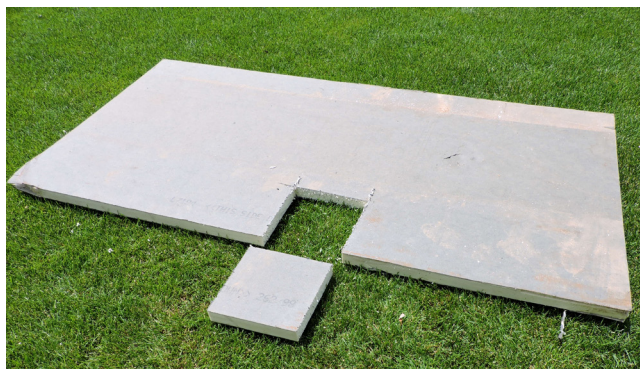
Figure 5. 17 year old polyiso sample

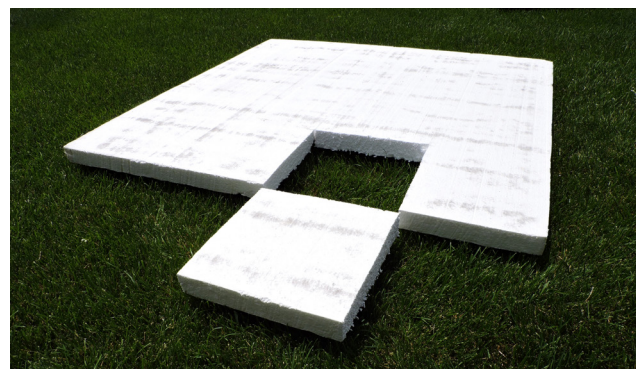
Figure 6. 17 year old Molded polystyrene sample
